DaliControl e64 Update Tool

– Firmwareupdate 3.1 Release 9

Application Note

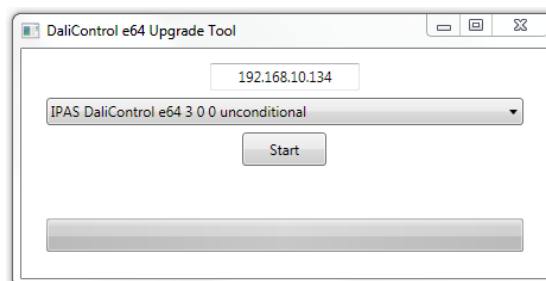
After the programme has been started, the following window appears:

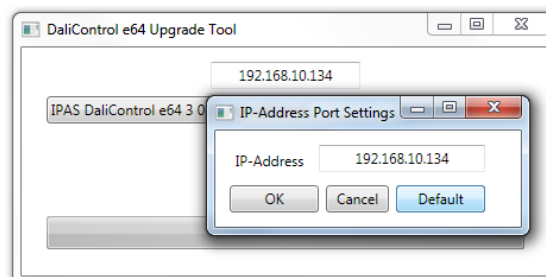
To start the update, enter the IP address of the device that you would like to update. Double-click on the displayed IP address (here 192.168.10.134) to open the entry field.

You can now edit the IP address and ensure it is correctly set to the required value. After pressing the OK button, the address is shown in the main window. Before you start the update, please select the required update type from the pull-down menu. The following types are usually available:

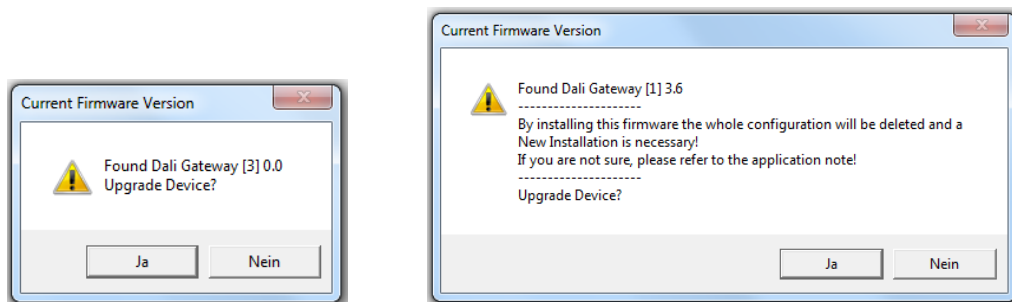
The update tool first checks the current firmware version of the Dali gateway and informs the user via an information window of the version that has been used up to now.

If you select “Unconditional” update, a further message appears in the window warning the user that the configuration data will be deleted.

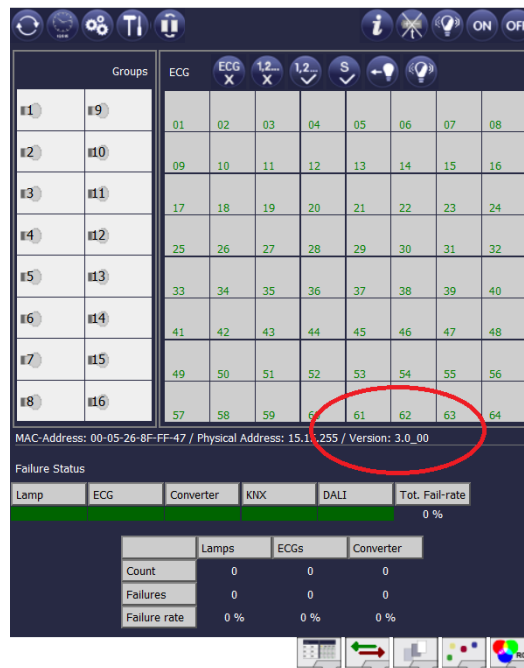
Alternatively, you can also check the current firmware version on the device website. The text box at the bottom of the ECG field displays the current firmware version in addition to the MAC address and the physical address of the device:
